Interactive CardioVascular and Thoracic Surgery 0 (2012) 1-2 doi:10.1093/icvts/ivr133

# Extreme windkessel effect can cause right heart failure early after truncus repair

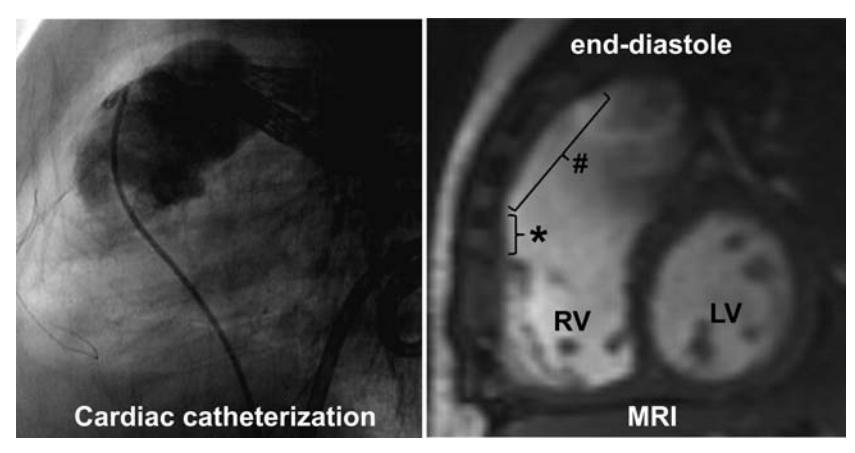
Figure 1: Left panel: sagittal view during cardiac catheterization depicting the pulmonary artery stents and the catheter in the pulmonary homograft. During contrast injection, the patency of the homograft and stents is confirmed. Right panel: sagittal view from cardiac MRI study. Dilated homograft (#) at end-diastole. \*RV outflow patch, LV, left ventricle; RV, right ventricle.

Twenty-four hours after the operation, the patient developed right heart failure. Transthoracic echocardiography demonstrated good RV function, no significant tricuspid regurgitation and good homograft valve function. Cardiac catheterization was performed 2 weeks postoperatively to exclude pulmonary artery problems: the pulmonary artery stents were patent (gradient 11 mmHg) with adequate run-off (Fig. 1, left panel). The catheterization was concise in order to limit contrast administration and radiation exposure.

During the following weeks, borderline haemodynamics persisted with inability to wean from mechanical ventilation despite optimal diuretic therapy. Echocardiography could only partially visualize the homograft due to its retrosternal position. A second catheterization was performed 4 weeks postoperatively and showed significant dilation of the homograft, moderately increased RV systolic pressure (48 mmHg,  $\sim$ 2/3 of left ventricular systolic pressure) with neither homograft valve stenosis nor distal pulmonary artery stenosis. Additional cardiac MRI demonstrated severe dilation of the pulmonary homograft (from 16 mm diameter to oval shape 38 × 24 mm over a length of 21 mm, whereas pulmonary valve diameter 95th percentile for BSA is 12 mm), a mildly dilated RV with good contractility and competence of the homograft valve (Fig. 1, right panel). Since the aneurysmal dilation of the homograft acted as a reservoir absorbing rather than transmitting the pulse wave to the pulmonary arteries, replacement of the pulmonary homograft by a 16 mm aortic homograft (EHB, Brussels, Belgium) was performed 49 days after the initial pulmonary homograft placement. An aortic homograft was used to have a more rigid, less compliant graft. This procedure soon resulted in significant clinical improvement. Peripheral oedema visibly decreased and the child was weaned from respiratory support within 4 days to be discharged 2 weeks later. At 1-year follow-up, the child is doing well, RV and homograft function are good and the aortic homograft is not dilated.

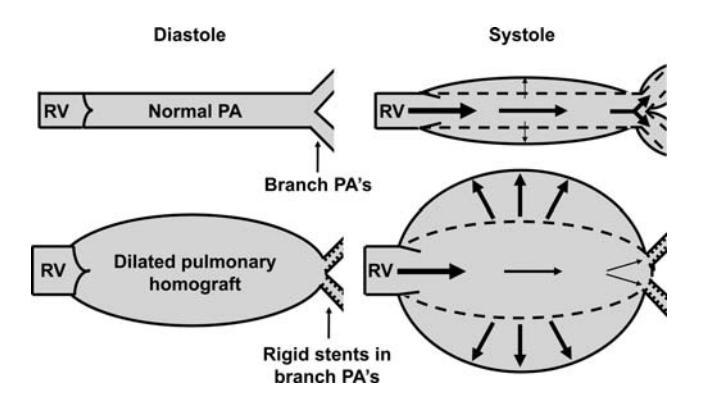
Figure 2: Schematic representation of normal physiological windkessel effect of the normal pulmonary artery (PA) and branch PAs (upper panel) resulting in adequate pulmonary perfusion. Pathological extreme windkessel effect of a dilated pulmonary homograft that absorbs rather than transmits the pulse wave (lower panel). In the lower panel, impedance is increased due to rigid stents in the proximal branch PAs and due to moderately increased PA pressure. RV, right ventricle.

mechanical obstruction. However, this case demonstrates we also should consider the possibility of a distended reservoir absorbing the pulse wave instead of transmitting it. This phenomenon can be explained using the windkessel model.

Windkessel means 'air chamber' in German, and refers to the concept of transforming pulsatile flow into laminar flow by use of an air chamber in the eighteenth century fire engines. The windkessel effect was introduced in medicine as a 'compliant, elastic reservoir' by Stephen Hales (1733) and later by Otto Frank (1899) [2]. The normal aorta, pulmonary artery and their large branches act as windkessel reservoirs: during systole, the pulse wave is attenuated by their compliance whereas during diastole, sufficient peripheral perfusion is ensured by elastic recoiling (Fig. 2). In this way, the windkessel properties allow conversion of ventricular pulsatile flow into continuous flow in the peripheral arteries [2, 3]. In our patient, two haemodynamic phenomena contributed to the extreme windkessel effect; first, the massive dilation of the homograft to 38 × 24 mm diameter and second, peripheral resistance was increased by the presence of rigid stents in the proximal pulmonary arteries. The extreme windkessel effect of this severely dilated homograft led to excessive attenuation of the pulse wave and insufficient pulmonary perfusion, thereby causing right heart failure.
